CULTURAL RESOURCES RECONNAISSANCE REPORT  
FOR THE SAIPAN SMALL BOAT HARBOR STUDY AREA,  
SAIPAN, COMMONWEALTH OF THE  
NORTHERN MARIANA ISLANDS

U.S. Army Corps of Engineers  
Pacific Ocean Division

March 1980

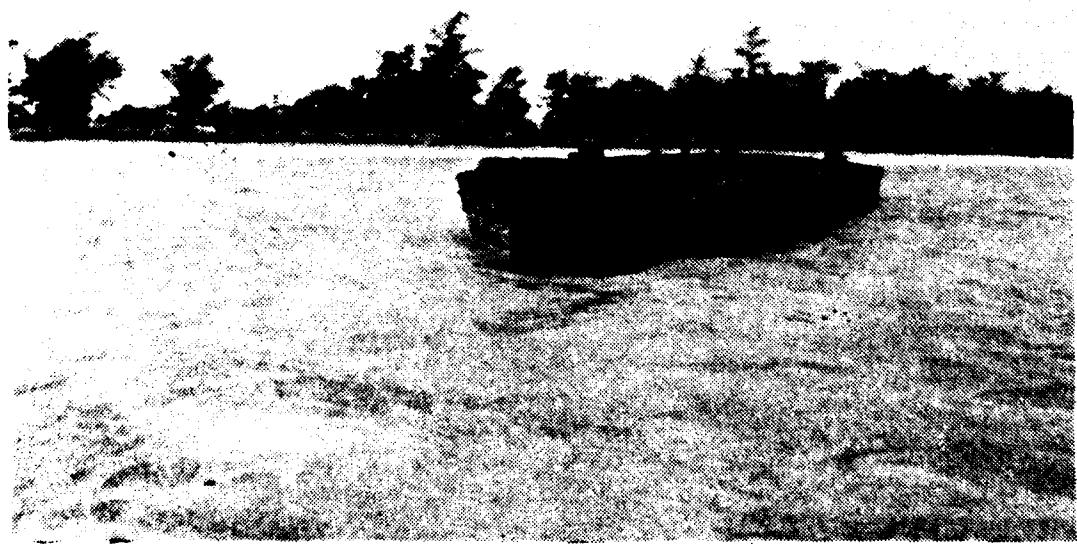
Object nine is a Japanese Harbor dredge (Figure 12) associated with it is the bucket with which it once kept the harbor free of silt. According to local informants there were two such imported dredges operating in Saipan before the war, but the location of the second is unknown. The steel hull and deck of the boat are in fair condition when compared with the pontoons in the same area, but it is doubtful that the boat could be moved.

Figure 12: Steel harbor dredge (Object 9) used by the Japanese before World War II.

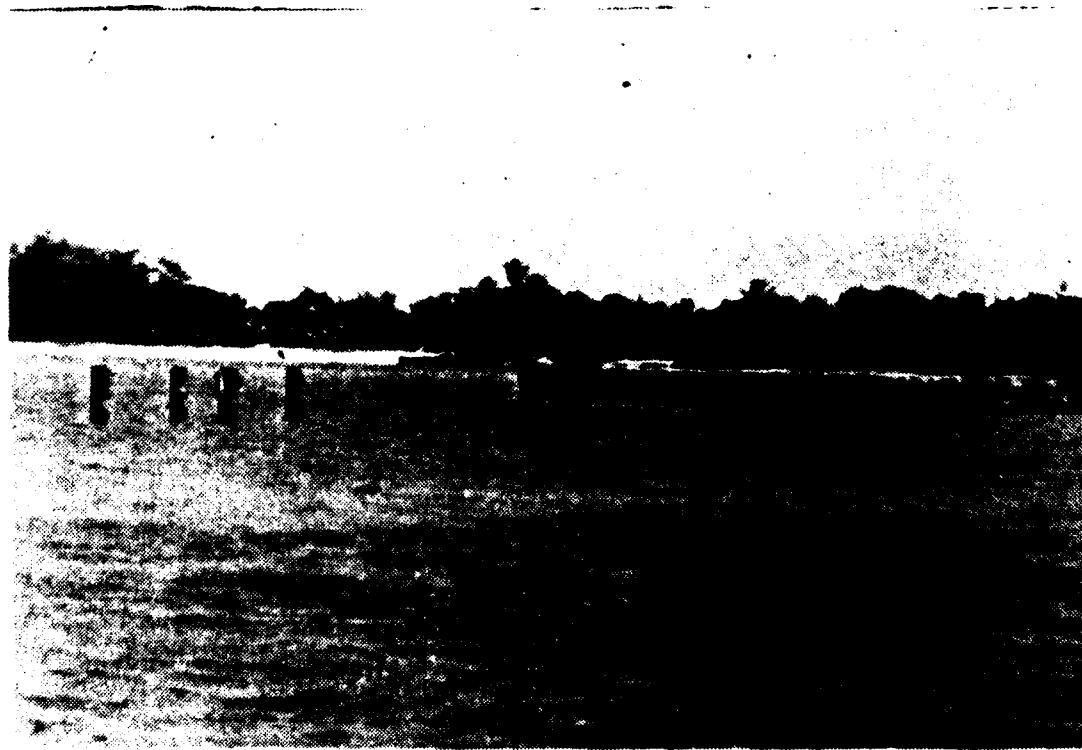
by the Japanese in the same area as the earlier German and possibly even a Spanish dock. The northern-most dock consists of a concrete wharf fronted by wooden pilings (Figure 14). Also according to local informants, this structure was the public and commercial dock for the city of Garapan during the German and Japanese eras. The southern dock (Figure 15) was not as large, and today consists of a pile of rubble near the shore fronted by wooden pilings, as in the case of the northern dock. Again according to local informants, the southern dock was the official Japanese dock supporting customs, immigration and coastguard facilities. It is unknown whether this southern dock also existed during the German period. After the American invasion of Saipan in 1944 the docks were repaired and used extensively to off-load support equipment and supplies. With the withdrawal of American forces after the war, maintenance of the docks lapsed, allowing them to deteriorate to their present condition.

Figure 14: Northern Fishing Base Dock in the Garapan area.

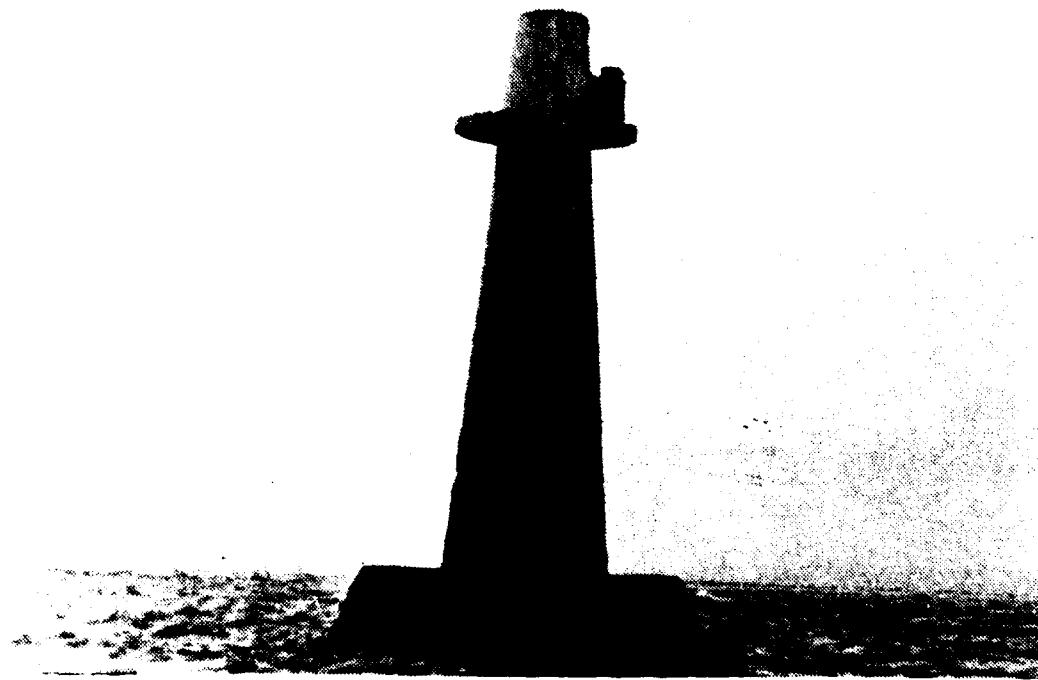
Object seventeen is a small concrete channel marker which stands on the barrier reef at the southern edge of the channel entrance (Figure 20). The structure, referred to as a lighthouse, has three components. The base is a large concrete trapazoid standing in 1.5M of water at mean low tide. The second component is a concrete pillar with a height of approximately 3M. On the north face of the pillar is the remains of a row of metal rungs which were used to climb to light the lamp. As may be seen in the photograph the rungs have vanished leaving only their sockets in the concrete. At the top of the concrete pillar is a collar of the same material which is broken on the north face to admit a climber. The collar supports a metal box on the seaward side housing the kerosene lamp which marked the channel. Whether or not a roof or some additional structure topped the pillar could not be ascertained as the pillar can no longer be climbed.

Today, the lighthouse marking Garapan channel is structurally sound and in generally good condition despite the pounding it takes when the seas are rough.

Figure 20: Japanese channel marker (Object 17) on the reef west of Garapan docks.

Regarding object seventeen it is recommended that construction plans be designed which do not endanger the integrity of the structure either directly, by removal of the coral on which it rests, or indirectly by exposing it to greater wave action from channel traffic. Further, more intensive investigation

might reveal more of the history of the lighthouse, and might explore the possibility that the lighthouse could be re-used or restored as an aid to navigation. In addition, further investigation into the construction and use of the docks at Garapan should be undertaken in order to determine their eligibility for nomination to the National Register of Historic Places.
